**Environmental Screening Report**  
**for**  
**Tk'emlúps te Secwépemc**  
**Engineered Waste Management Facility**

**September 2021**

**Grasslands Organics**

**Lakeshore Environmental Ltd.**

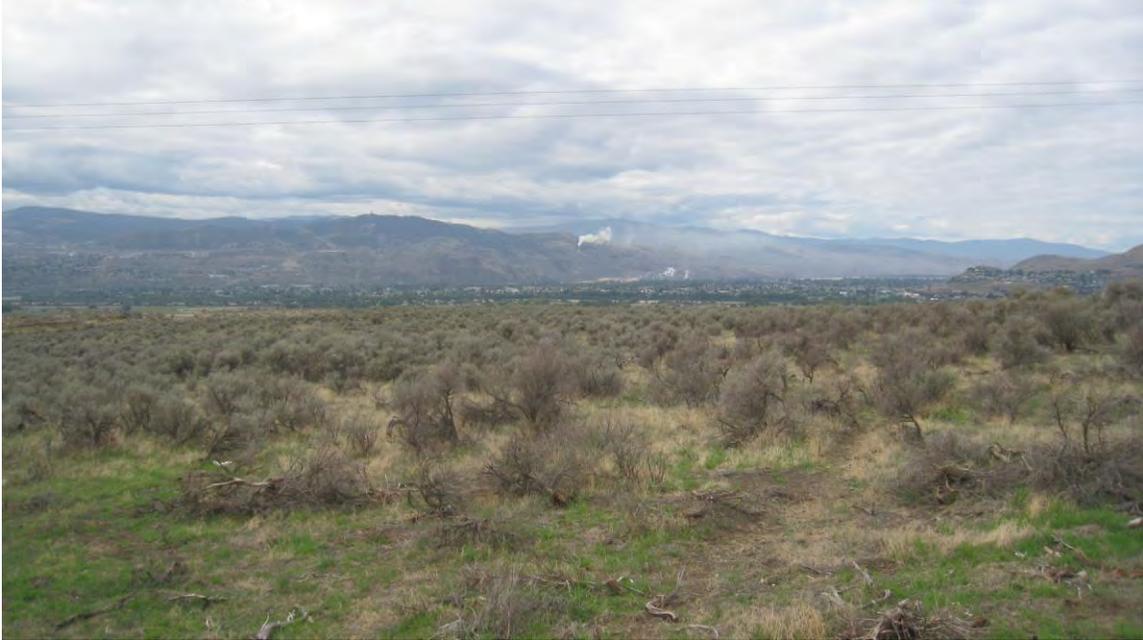
**Photo 1. View to southwest showing site & city.**

The site is situated on a relatively flat bench above Paul Creek Road and Paul Creek to the south (*Photo 1*).

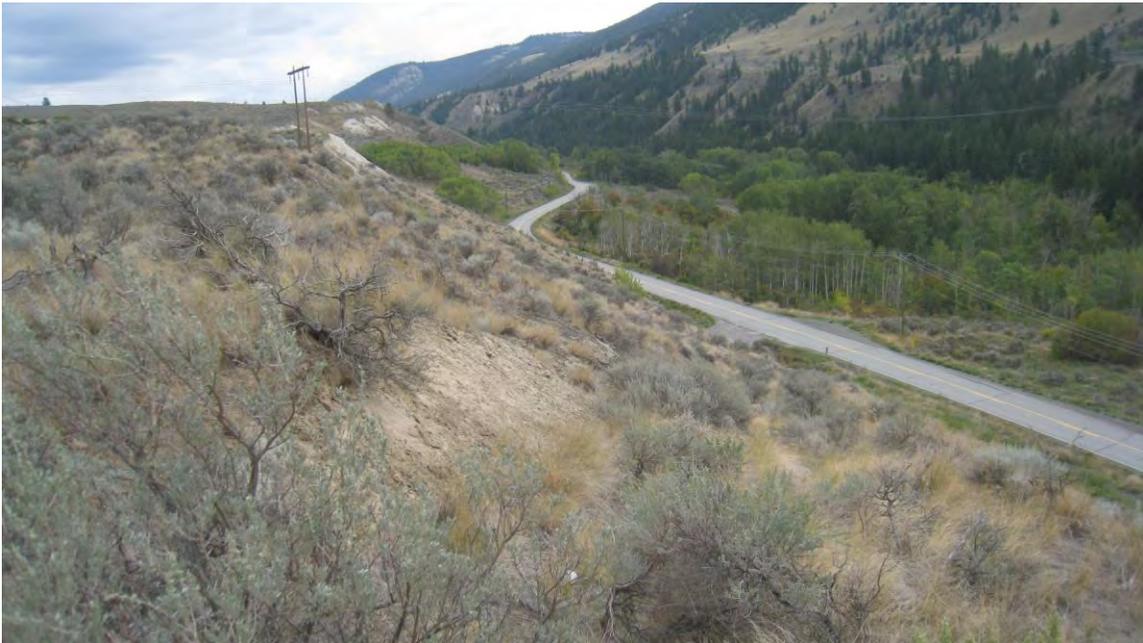
**Photo 2. Embankment overlooking Paul Lake Rd.**

The southern part of the proposed site has a sharp cut down to Paul Lake Road (*Photo 2*).

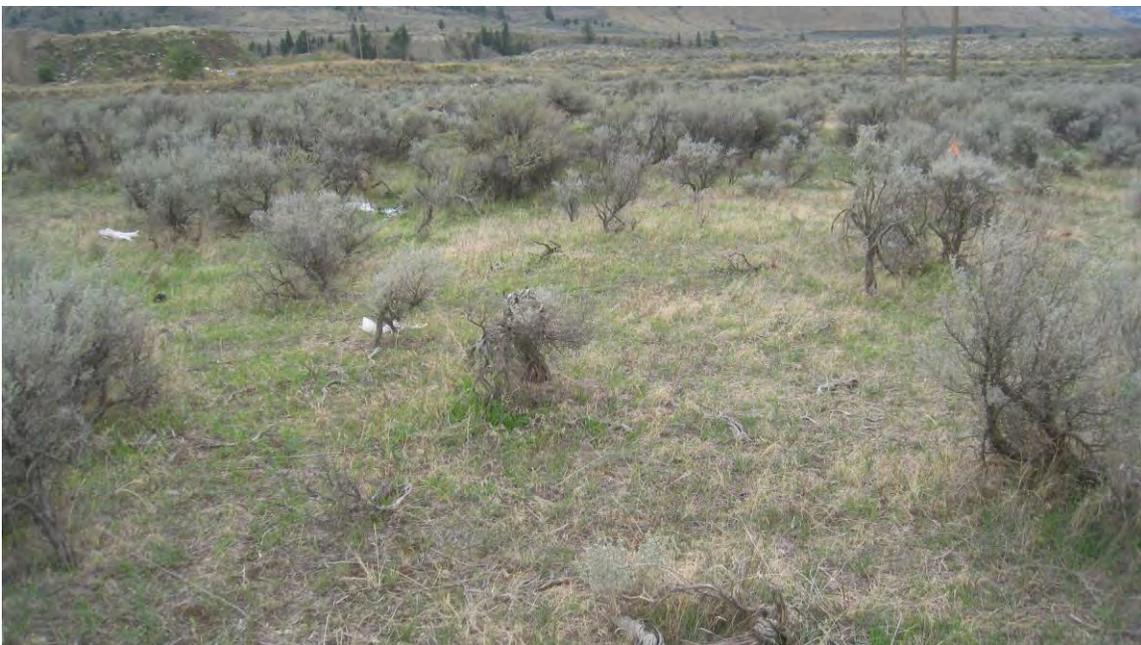
**Photo 3. Typical vegetation in grazed area.**

Vegetation on the property consists of mainly of sagebrush with smaller amounts of crested wheatgrass, cheatgrass and cacti. The northern portion of the site has been heavily grazed and plants such as crested wheatgrass have been reduced to only a few centimeters in height (*Photo 3*).

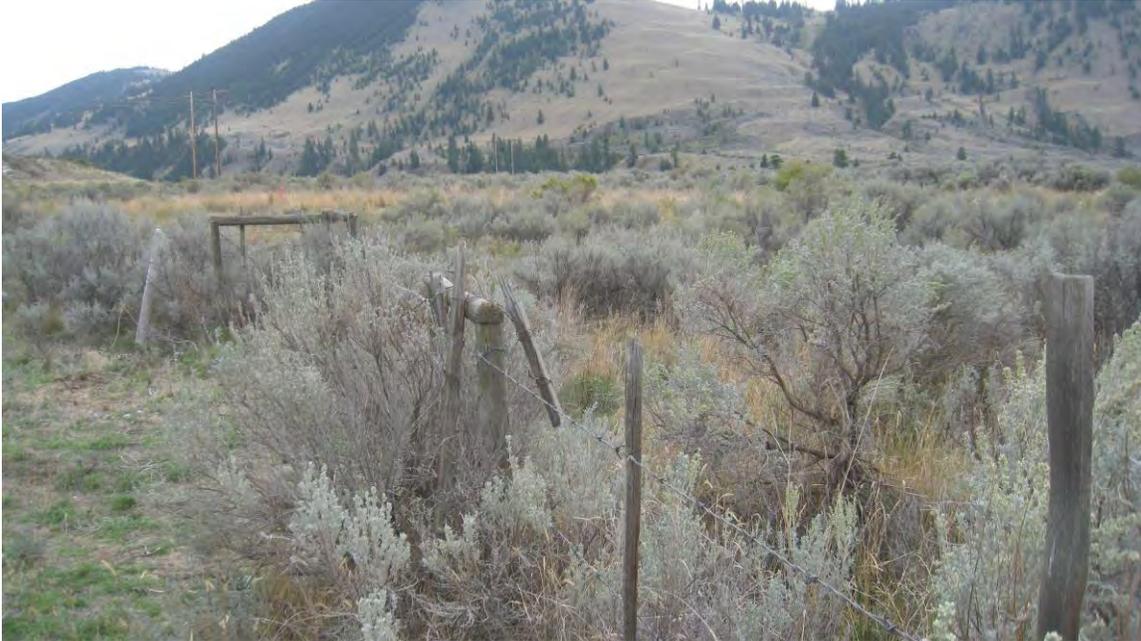
**Photo 4. Ungrazed portion of site showing vegetation health**

A small section of the south portion of the property is fenced off and the vegetation is noticeably thicker and healthier (*Photo 4*).

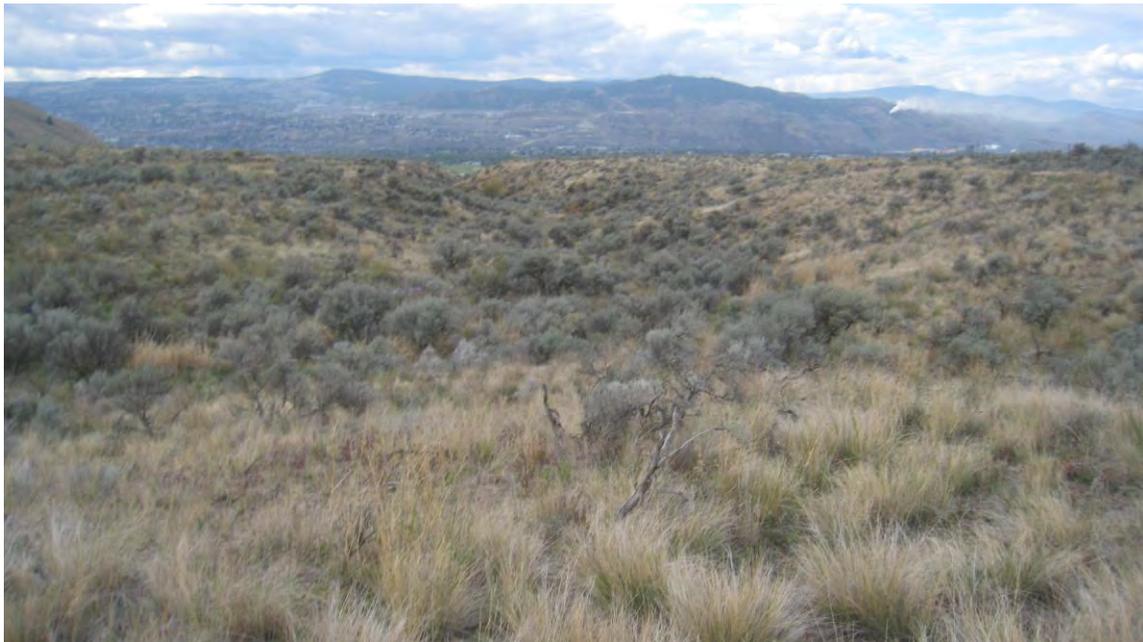
**Photo 5. Major gully on property**

There is one major gully (*Photo 5*) and several minor ones that run in a southwesterly direction towards Paul Lake Rd. (*Photo 6*).

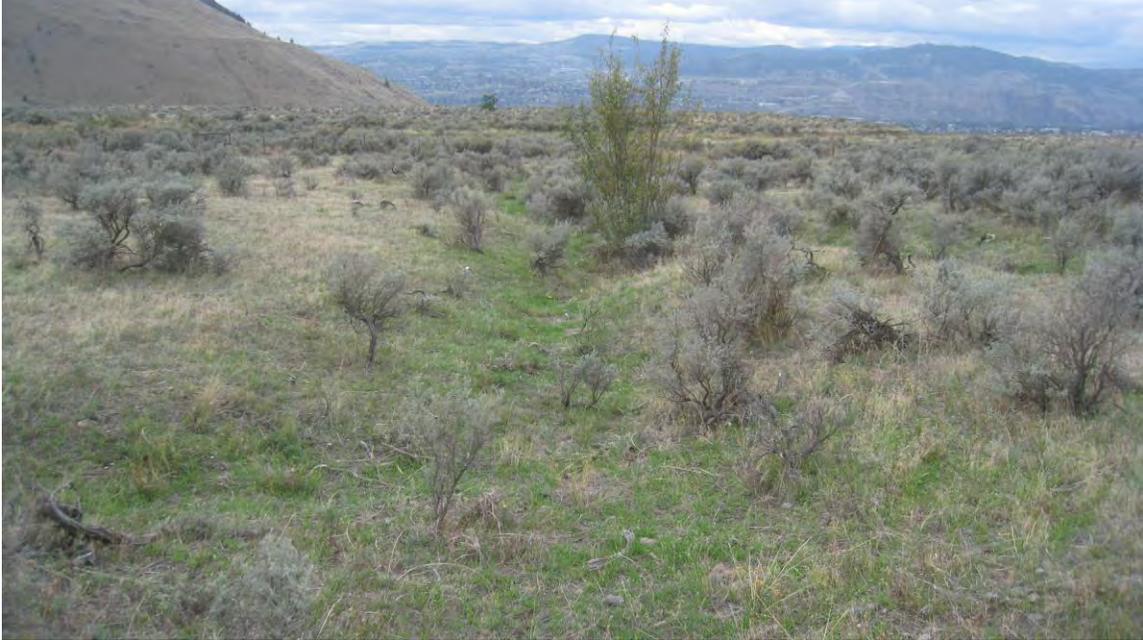
**Photo 6. One of several small gullies on site**

It is assumed these may carry snowmelt water in the spring but are dry throughout the remainder of the year. A decommissioned road that used to service the original TteS landfill is still evident on the property (*Photo 7*).

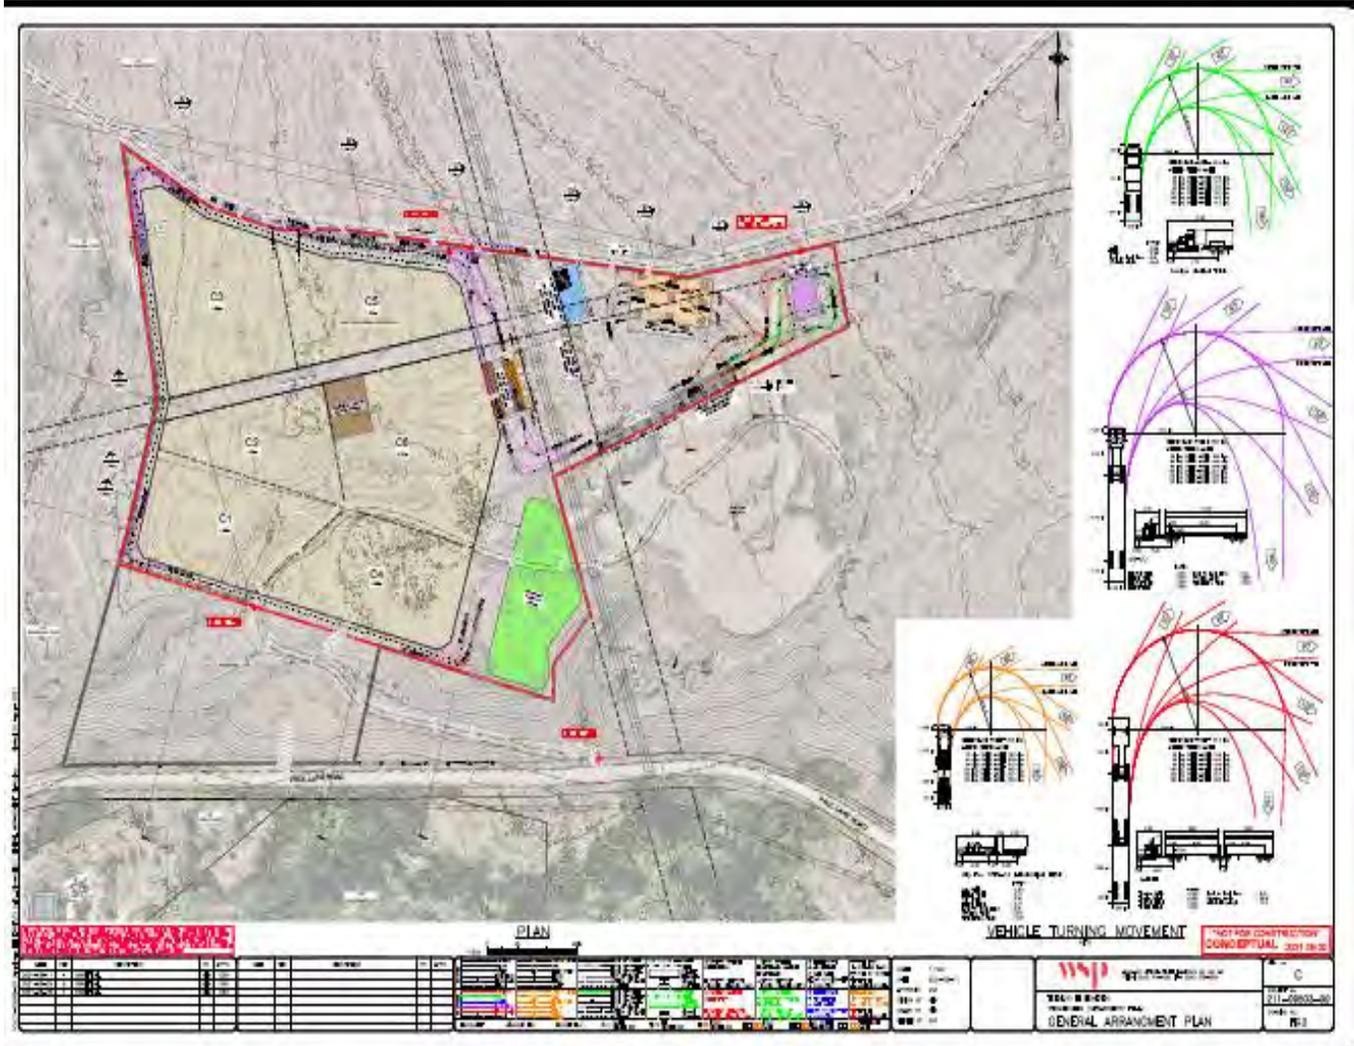
Figure 2. Schematic of project design.
